# Failure mechanisms and structural response of CIPP-Rehabilitated concrete pipes under external loads

Reinforced concrete pipe(RCP)  
Cured-in-place pipe(CIPP) lining  
Three-edge bearing test (TEBT)  
Failure mechanism  
Stiffness superposition

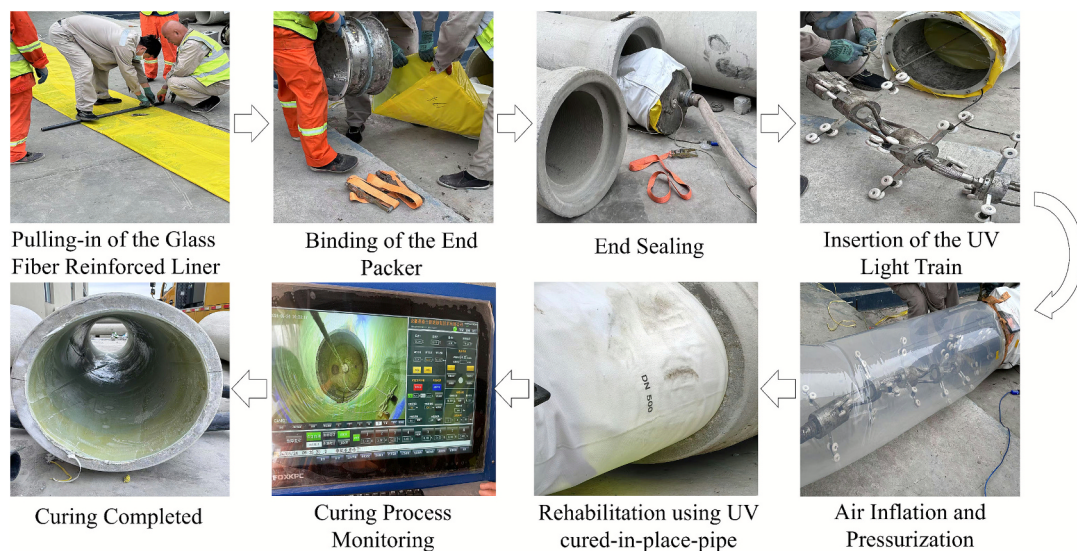
Fig. 2. CIPP Lining Preparation Process.

The CIPP liners used in this study consisted of fiberglass fabric impregnated with an unsaturated polyester resin. A medium-sized UV-curing system equipped with a  $4 \times 1000$  W high-pressure mercury lamp was employed to rehabilitate 15 m-long DN800 concrete pipes, simulating the in-situ repair process of underground drainage pipelines. The preparation and curing procedures are illustrated in Fig. 2.

- A protective membrane was fixed at both ends to cover one-third of the pipe circumference, preventing liner abrasion.
- The liner was pulled into the concrete pipe at a rate of 5 m/min using a winch-driven rope.
- Safety collars were installed at both ends, and exposed sections were wrapped as required.
- After the blower reached stable operation, the liner was inflated and maintained under pressure, while the UV lamp guide rope replaced the pull rope.
- The lamp carriage was inserted, end plates sealed, and internal pressure increased to 250 mbar to ensure full contact with the host pipe wall, monitored by an internal camera.
- The UV lamp chain was then activated and advanced at a constant speed of 0.3 m/min for curing, after which pressure was gradually released to atmospheric level.

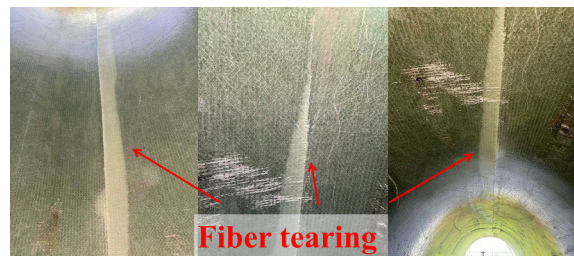
Fig. 19. Failure Cracking of the CIPP Liner.

The destructive testing results of the RCP-CIPP composite structure are shown in Figs. 18 and 19. The CIPP specimen exhibited a typical degradation pattern of flexible pipes under external loading, undergoing significant vertical deformation without initial damage until deformation reached approximately 20–30 % of the pipe diameter, at which point compressive failure occurred at the springlines. Compression of the fiber mesh led to local bulging of the surface resin layer.
